A trouser belt saves the day - By George Milburn

A trouser belt saves the day - By George Milburn (Continued)

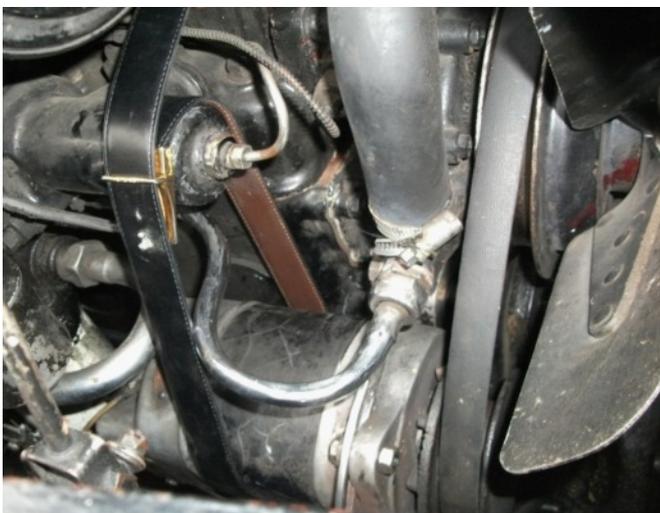
a slight discharge and so, when I stopped at a service area for petrol and tea, I lifted the bonnet. It was obvious that the back of the dynamo had fallen down, making the dynamo pulley skew and, although the belt was still on the pulley, it would be slipping somewhat. The dynamo rear support bracket had broken or come loose somehow but it was supported on the front bracket and the top front, slotted, adjusting, drive belt tightening link.

Italian belt holding dynamo for 800 kms

The front slotted link was adjusted to tighten the drive belt again and off we went as normal! There was sufficient charge from the dynamo for the ignition and wipers or fog lamps but a slight discharge was shown when the headlamps were on. Thus we were able to proceed through France to our hotel, Relais St John, in Troyes. The next day we travelled to St Omer, which is near Calais. In deference to the probable slight slackness of the belt we limited our cruising speed to about 70mph. Water temperature was as normal during this stage of the journey, but remember that our car has the radiator slats opened up as recommended in RROC (Australia) MK VI articles and thus air flow through the core is improved.

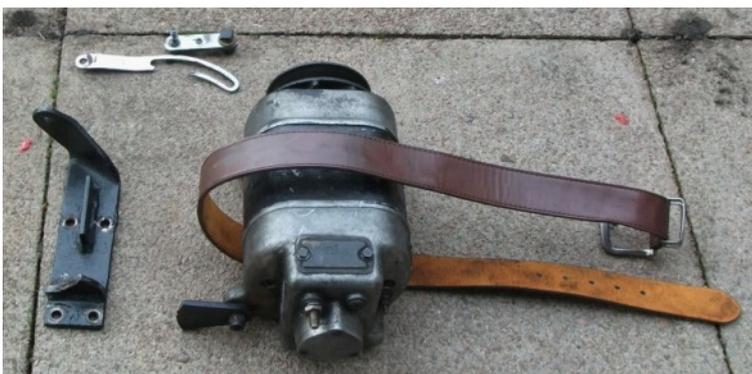
Broken Bracket on disassembly

Once home it was discovered that the rear support on the bracket had sheared completely and this was re welded with an additional strengthening web along the support. Several years ago the front of this same bracket had bent and the author had had to add a strengthening web in the centre of the backplate. This can be seen in the photo. It is probable that this bracket was designed for the smaller 4.5 inch dynamo, which was fitted to earlier cars and just is not strong enough for the heavier unit. As mentioned, the adjusting slotted link had split and it was not easy to find a new one from the suppliers approached. A similar link for a Triumph TR2 / Morgan +4 was acquired and a new hole drilled in the shortened end to make it fit. This was at least twice as strong as the original, adjusting, link on the car, although it was not chromed. The original, chromed item did look rather flimsy. Several engine fittings on the car are chromed as, originally, it was to be used on the Mulliner stand at Earl's Court. Eventually it was used for so many trials, messing about, that they decided not to use it.
