## CENTRE STEERING LEVERS & PIVOTS ON IMMEDIATE POST WAR CARS - by George Milburn

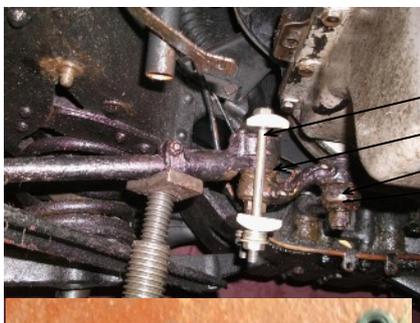
Cross steering tube to wheel link  
Clamp  
Ball Joint  
Central cross steering tube between idlers  
Steering idler arm cross steering tube ball

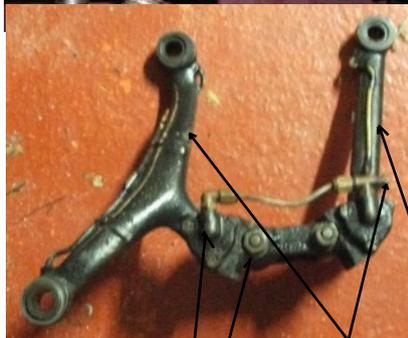
Side steering tube connection  
Idler pin top covers  
Pin clamping bolts  
Idler arms  
Oil supply connection

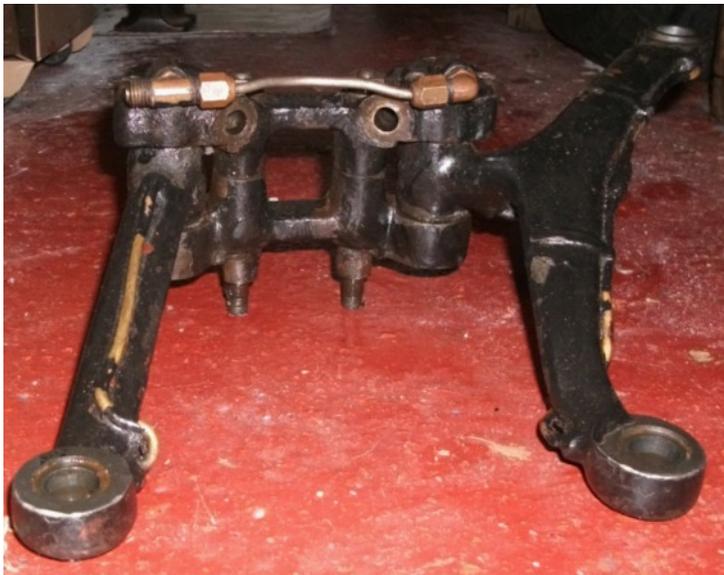
On the author's car, however, there was no sideways play in any of the 4 idler bushes. There was play, however, in the vertical movement of the pins, as originally observed. This is adjusted by inserting disc shims beneath each pin into the bottom of the lower bearing of the pin concerned. It will be found that the original shim will be worn somewhat, thus allowing this end play in the idler pin. The original worn shims were removed and their thicknesses measured across the outer worn areas. The centre of each disc was found to be relatively unworn as the centre of the pivot pin houses spring loaded pins, controlling oil flow . New shims were cut from shim steel in various thicknesses and fitted until there was no play while being able to rotate the levers easily. The assembly was then dismantled and the pivot pin end springs refitted. Pin end play & movement were then rechecked. The assembly was then refitted into the front chassis crossmember. The chassis lubrication supply pipe union was reconnected and the cross steering linkage rods connected to the steering idler levers with the ball joints. The side steering tube was then

central mounting bracket, undoing the two angled horizontal securing nuts and sliding out the assembly. The idler pins are mounted in their bracket with brass bushes top & bottom. The bracket is taken apart by undoing the vertical pin top clamping bolt nuts. The idler pins are spring loaded axially in the bearings and it is recommended to remove these springs to more accurately check the end play. If there is sideways play in the bushes they will have to be machined out & new bushes pressed in, as advised in the manuals. The harder, forged pivot pin should also be checked for diameter & roundness, especially where rust is present. This will occur if there is inadequate oiling from the lubrication system. Normally the wear is more likely to be in the brass bush rather than the harder steel pin. If the pin is worn or corroded it will need turning to round and the brass bush will then have to be turned to size or the pin can be flame sprayed and finished to size, of course. One also has the option of white metalling the bush? Chrome plating has also been suggested in RR documents.
